**PROPERTY DISCLOSURE - RESIDENTIAL ONLY**  
New Hampshire Association of REALTORS® Standard Form

2. PROPERTY LOCATION: 562 Pickering Rd, Rochester, NH 03867

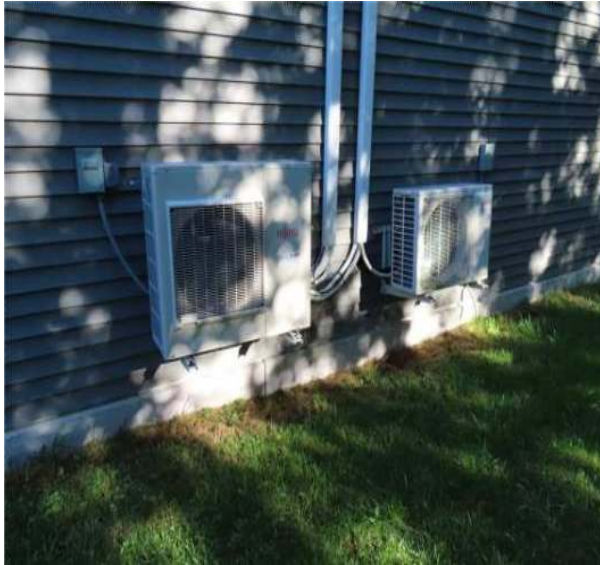
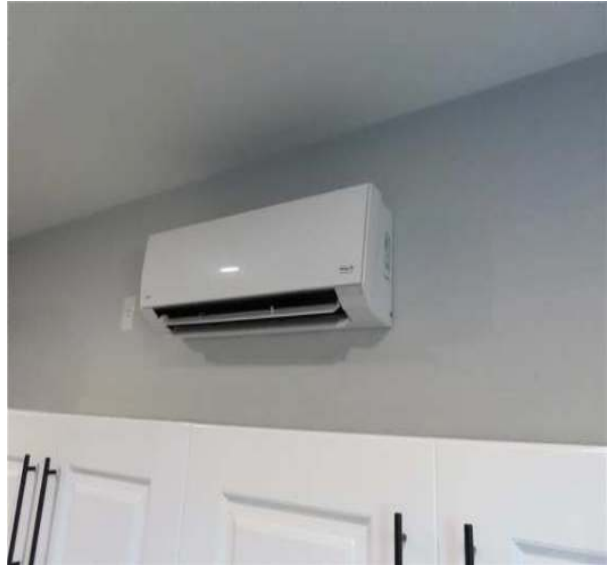
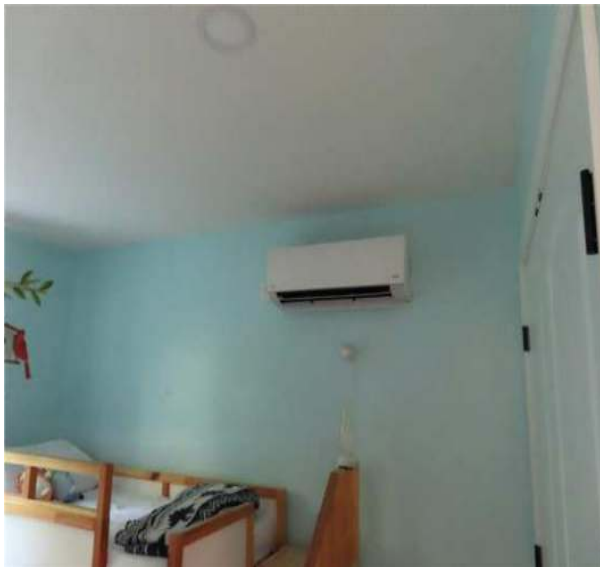
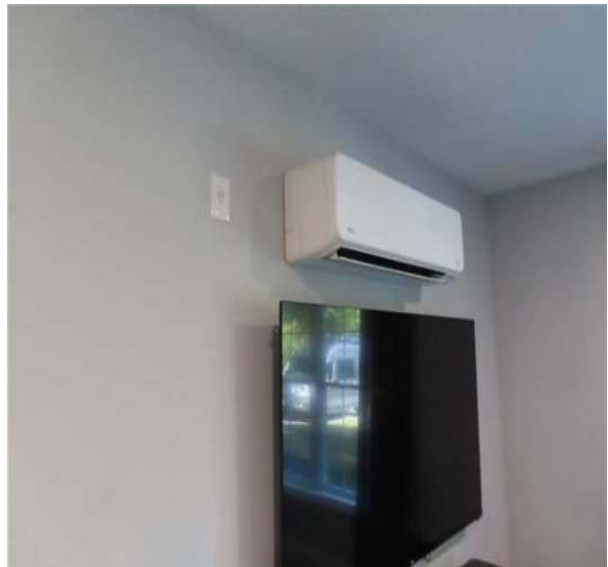
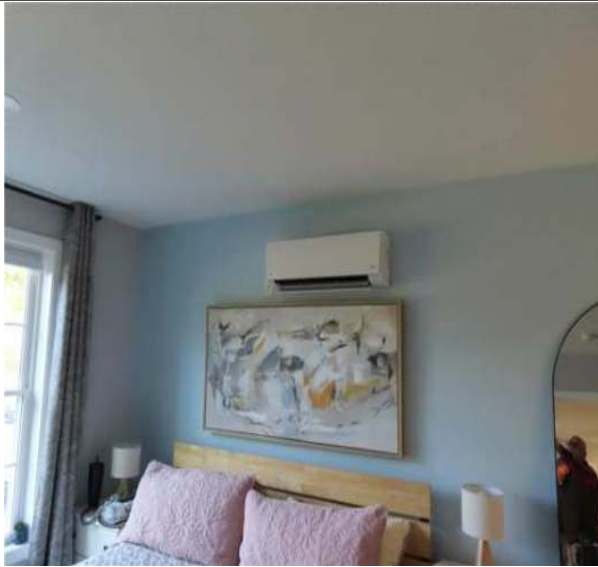
The mini split heat pump and air conditioning units are operating as designed.

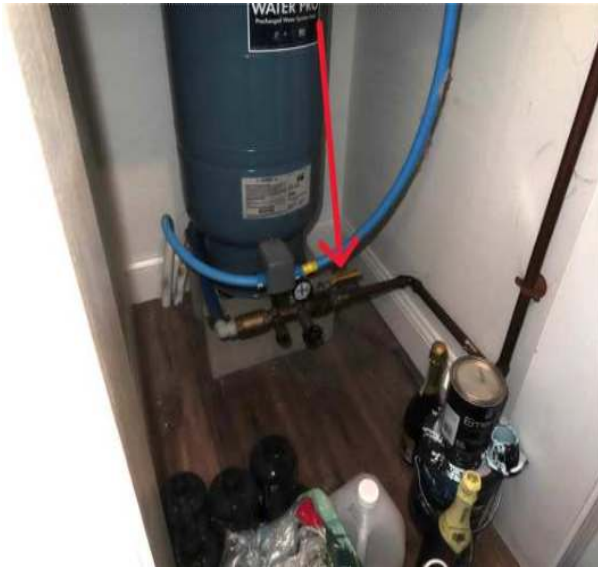
IMG\_4290.JPG

The Main water shutoff for the home is in the laundry closet, it is the yellow handled lever at the base of the blue pressure tank.

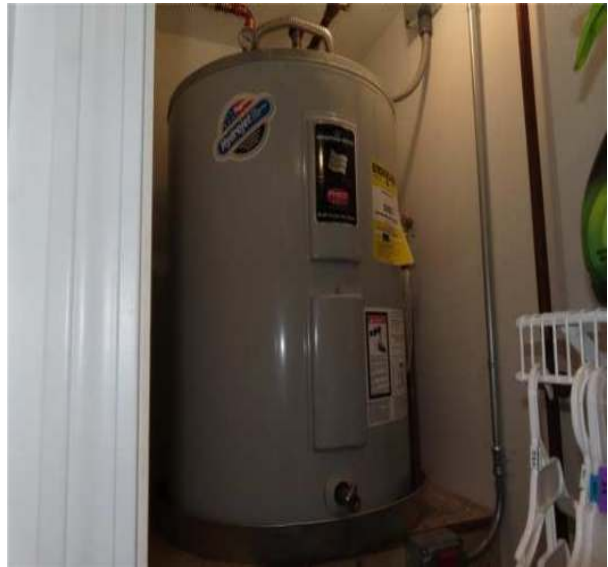
IMG\_4291.JPG

The four year old 37 gallon electric water heater is operating as designed.

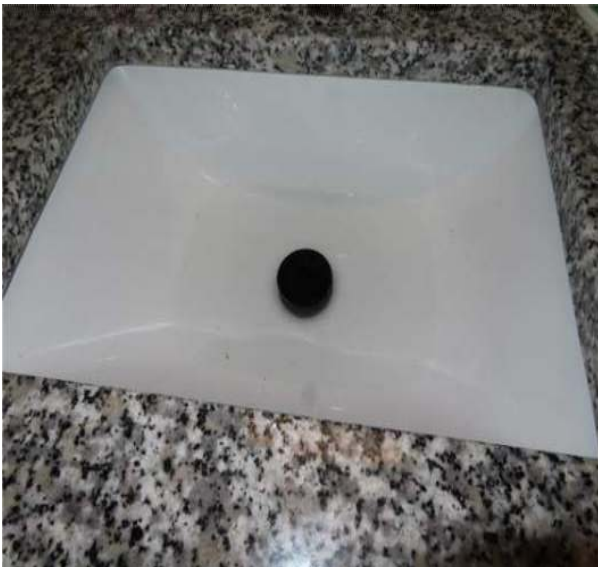
IMG\_4307.JPG

The primary bathroom vanity sink drains slowly, most likely needs hair cleaned out of the drain.

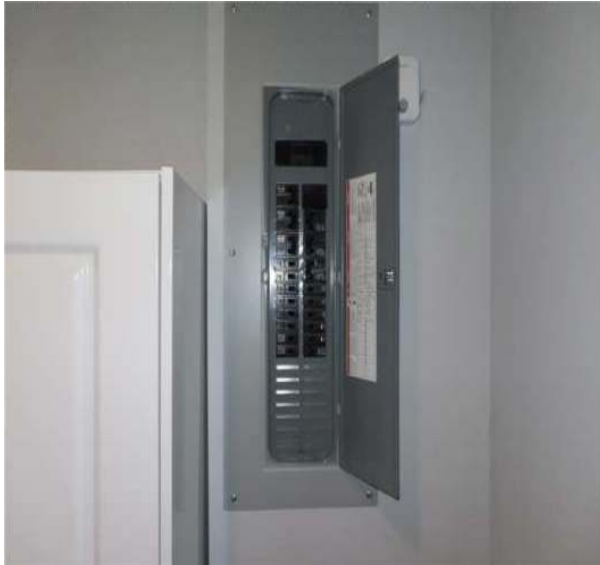
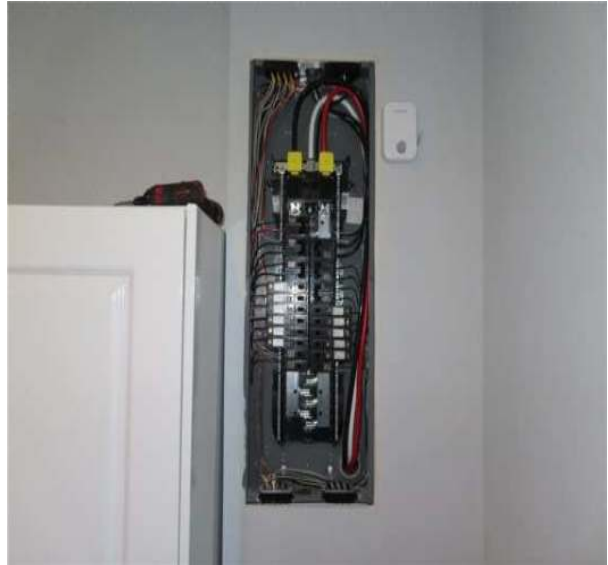
The main electrical panel is located in the right front bedroom, no issues were observed inside the panel.

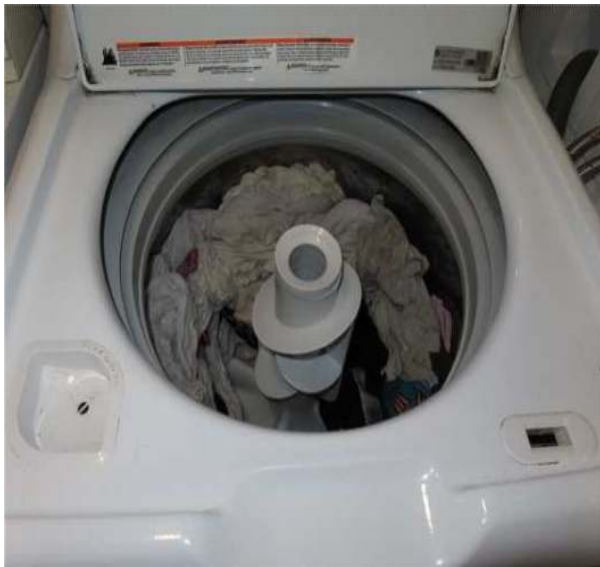
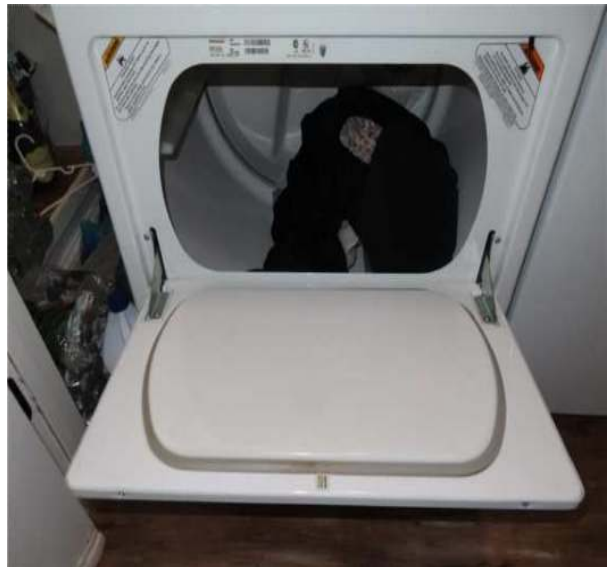
The washer and dryer had clothes in them and were not tested during the inspection.

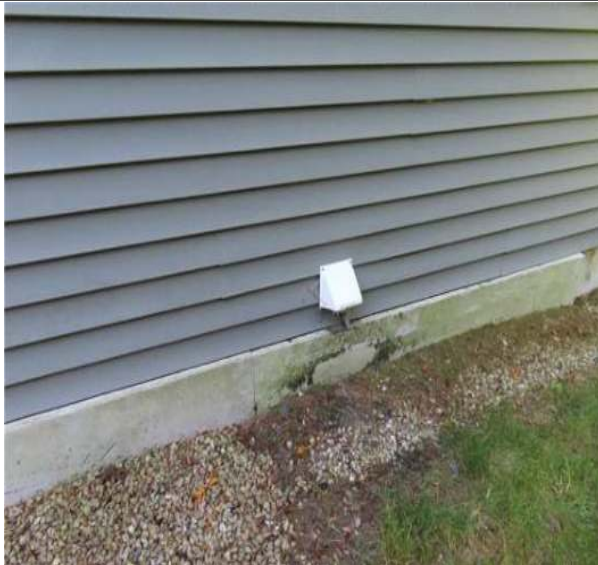
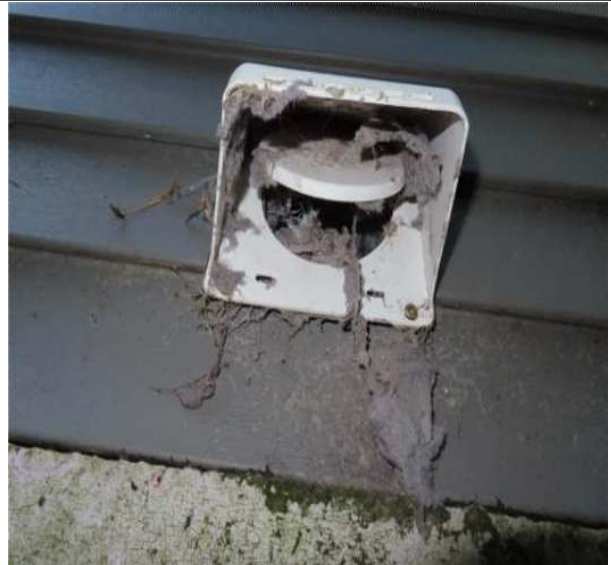
| Remarks | <b>The washer and dryer had clothes in them and were not tested during the inspection. The dryer duct and outlet need to be cleaned for fire safety. Recommend using the washer water shutoffs when not using the washer.</b> | |

The dryer duct and outlet need to be cleaned for fire safety.

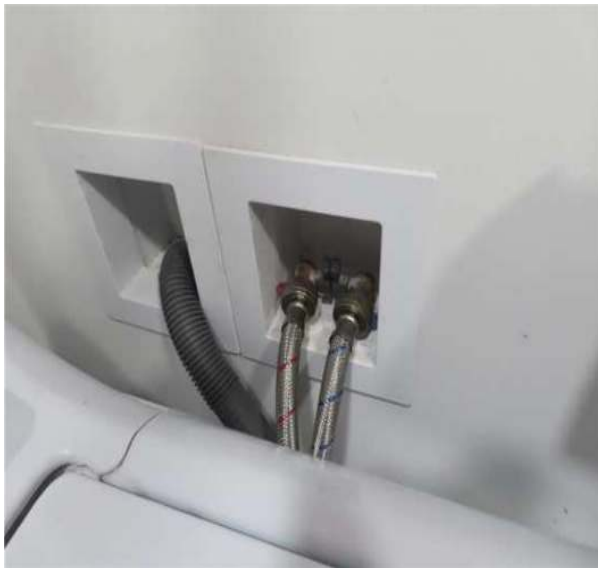
IMG\_4293.JPG

Recommend using the washer water shutoffs when not using the washer.

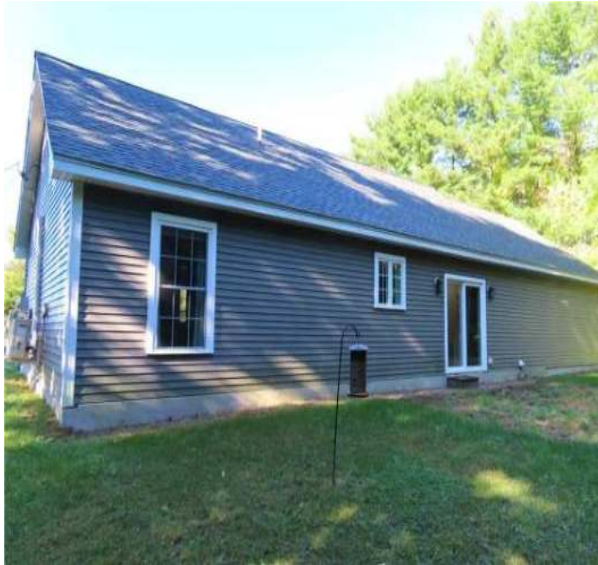
IMG\_4272.JPG

| Remarks | <i>There are no outlets on the exterior of the home for the bathroom exhaust fans. The fans may be ducted to the soffit vent area of the attic but that will not get the moisture from the bathrooms out of the building. The bathroom exhaust fans need to be ducted out of the building through outlets designed for this.</i> | |

There are no outlets on the exterior of the home for the bathroom exhaust fans.

*The fans may be ducted to the soffit vent area of the attic but that will not get the moisture from the bathrooms out of the building. The bathroom exhaust fans need to be ducted out of the building through outlets designed for this.*

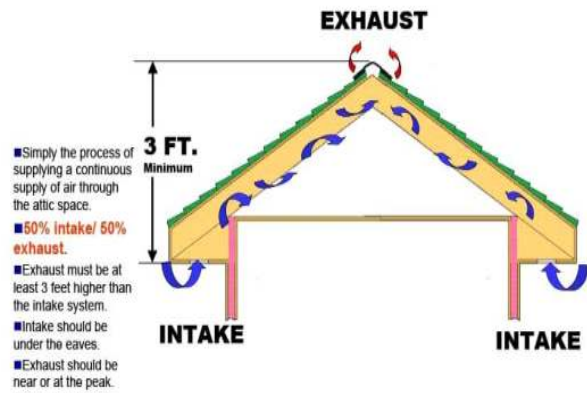
Attic ventilation.jpg

The fans may be ducted to the soffit vent area of the attic but that will not get the moisture from the bathrooms out of the building.

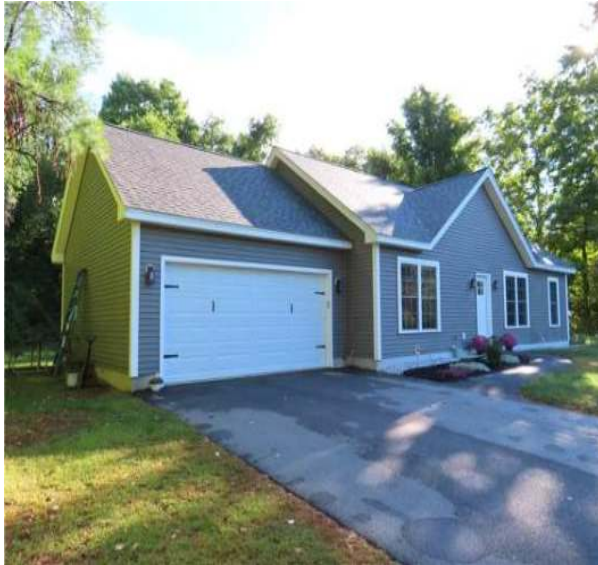
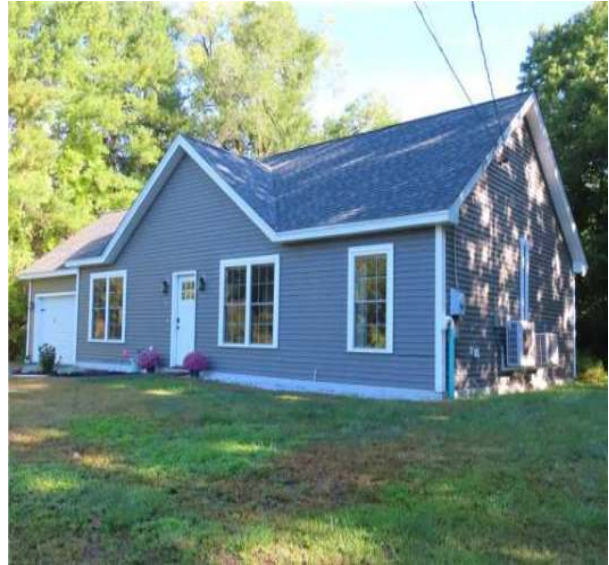
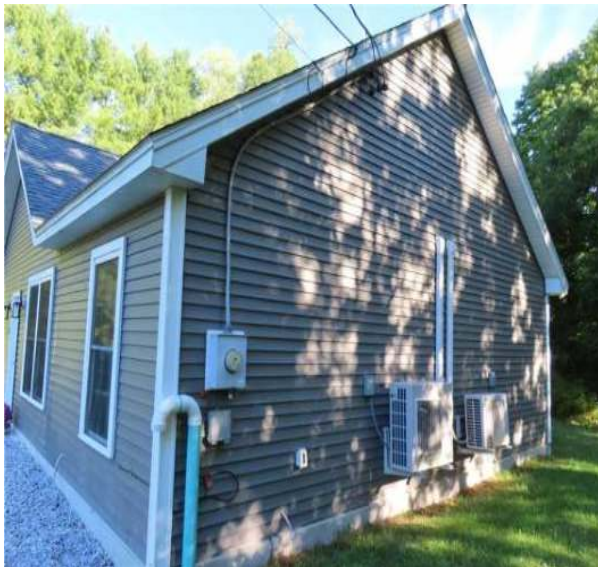
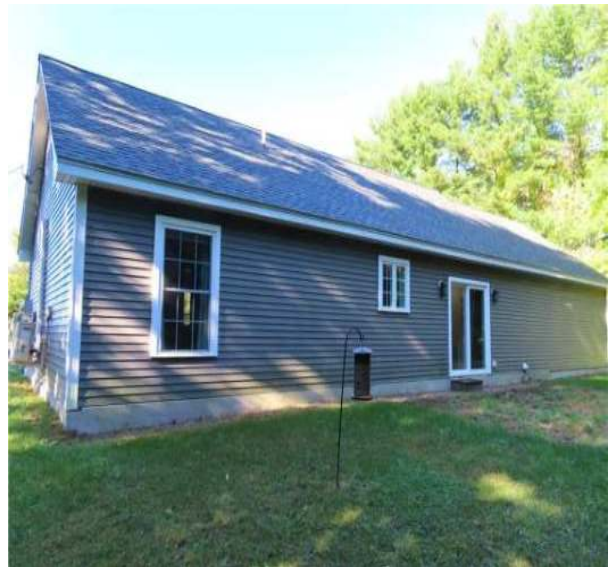
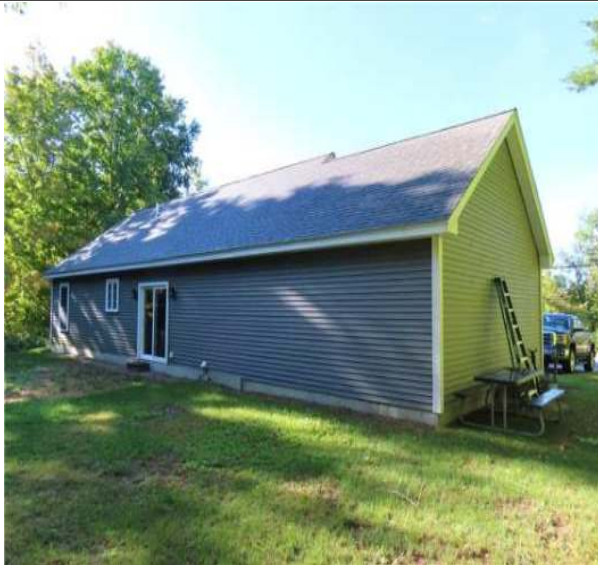
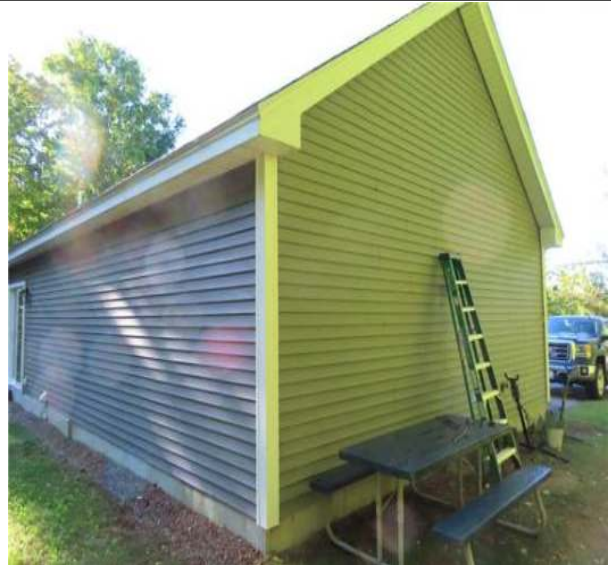
The roof and exterior of the home are in good condition with only minor issues observed.

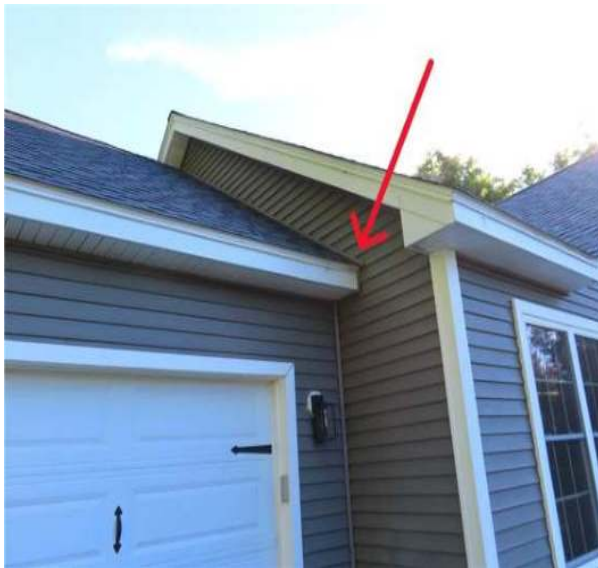
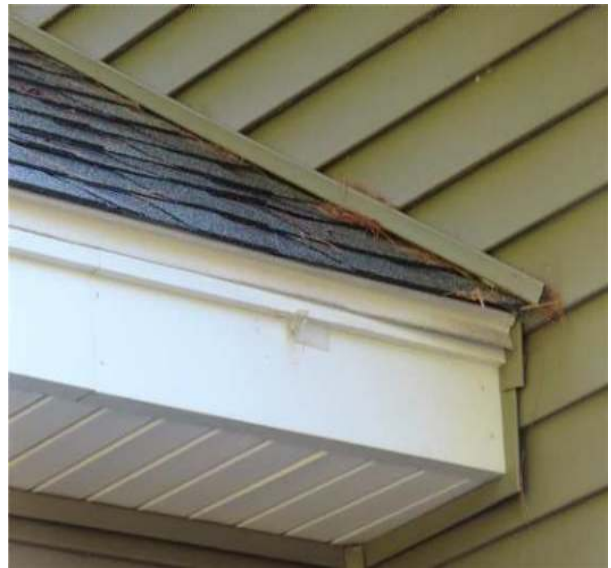
There should be kick out flashing at the bottom of the garage roof where it ends beside the exterior wall home.

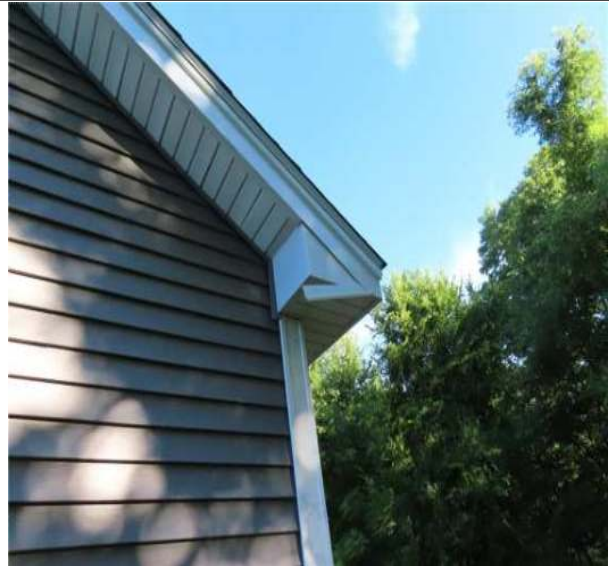
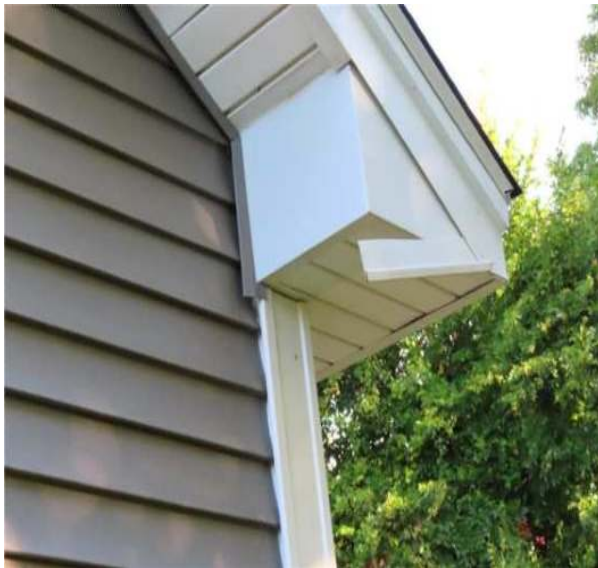
*\*There is a loose piece of gable rake trim on the right side rear bottom corner that needs to be secured in place.*

There is a loose piece of gable rake trim on the right side rear bottom corner that needs to be secured in place.

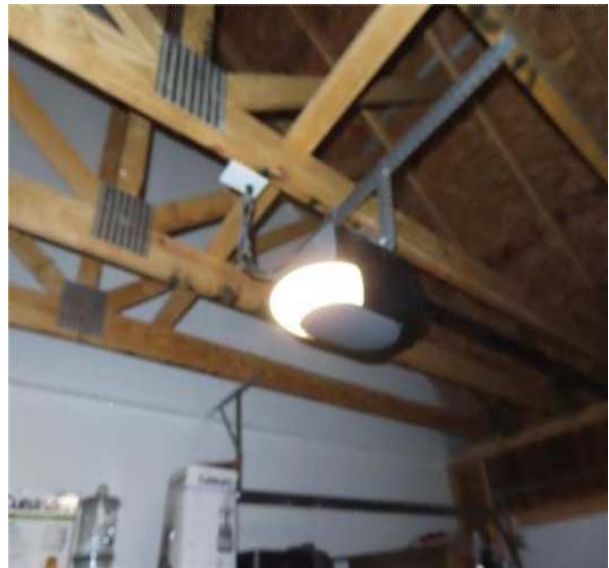
IMG\_4289.JPG

The garage door opener needs the downforce safety reverse adjusted for safety.

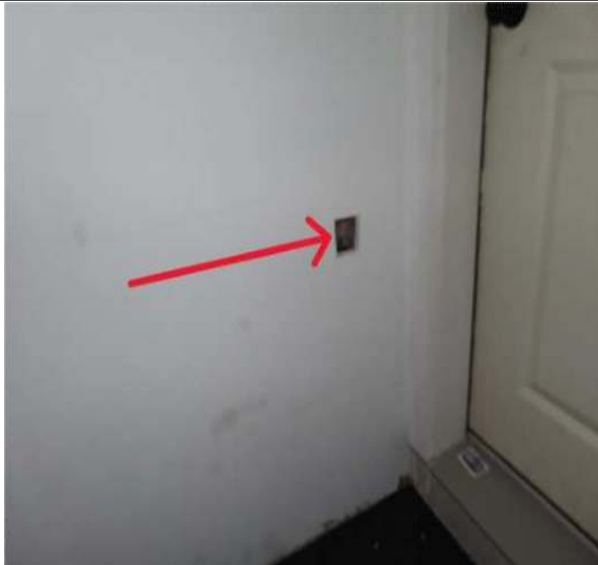
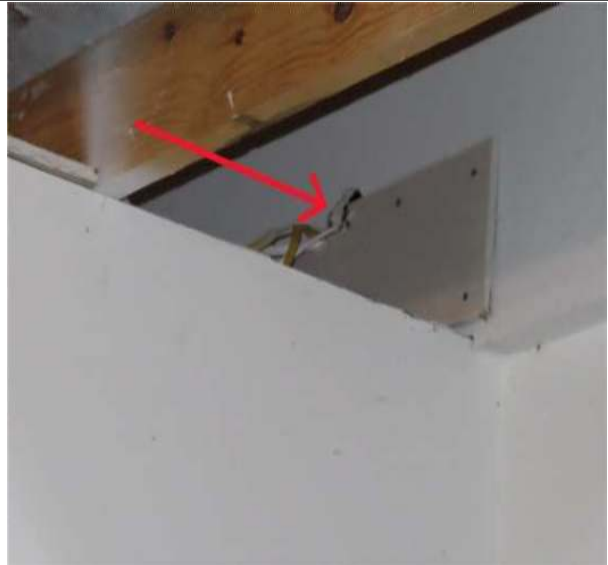
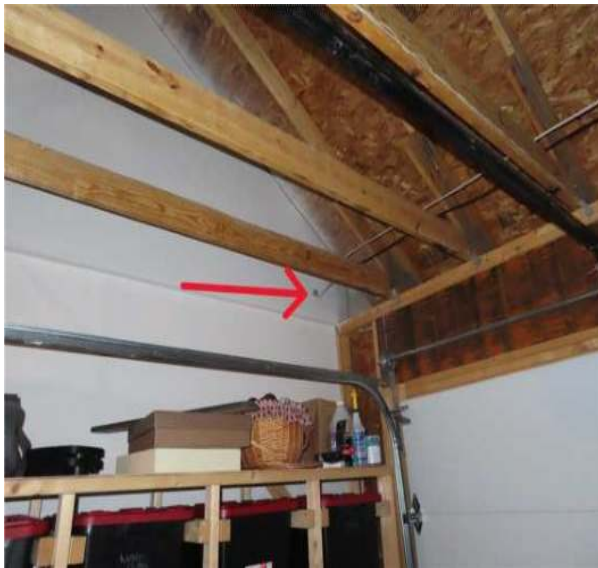
The holes in the garage firewall from installing wiring need to be sealed with fire rated sheetrock, there should be no openings in the firewall.

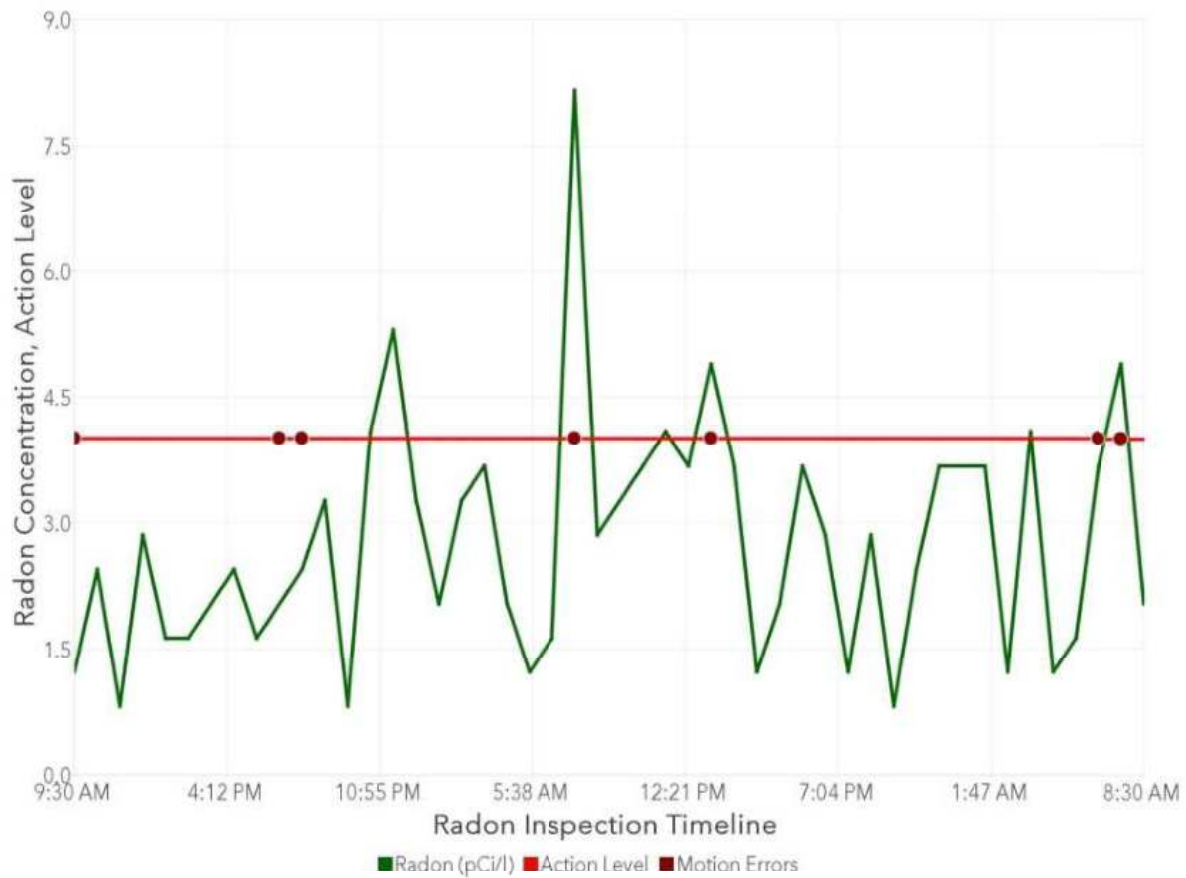
## Radon Inspection Chart

**Test Result: Pass**
