WOOD DESTROYING PESTS AND ORGANISMS INSPECTION REPORT

Building Address: 786 Main St., Cambria, CA 93428		Date of Inspection: 04/10/2025	Number of Pages: 8

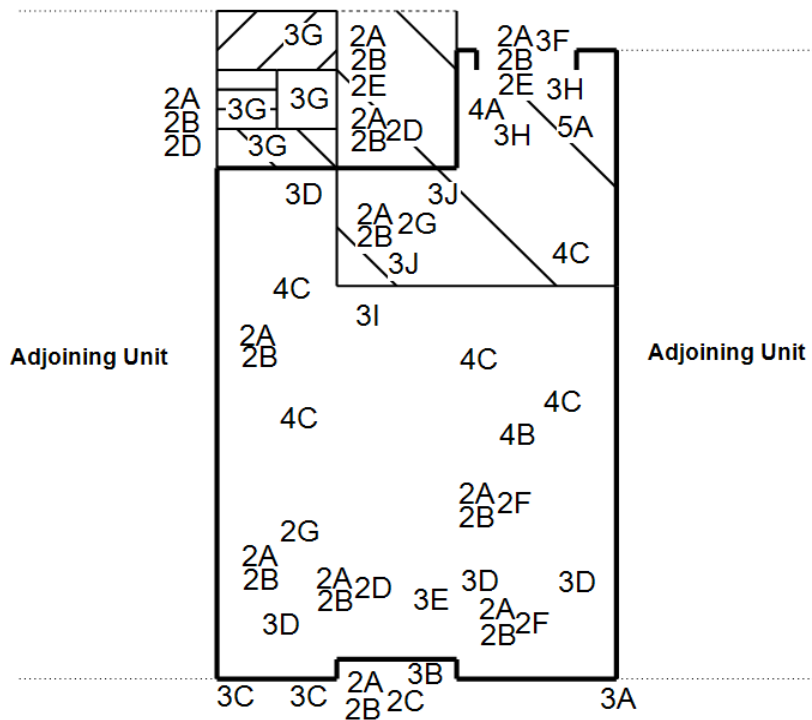
- 2A PRICE: Bid Upon Request (Section I)
 FINDINGS: Evidence of drywood termite infestation at the fascia, railing, deck, sub floor, and the attic framing as indicated on the diagram.
 RECOMMENDATION: Vacate the premises and seal the structure for fumigation of drywood termites with Vikane Gas. Remove or cover accessible evidence of infestation. Fumigation guaranteed for FIVE YEARS. Treatment type during guarantee will be the sole judgement of 805 Termite Control. Fumigation awareness notice must be signed prior to fumigation. See fumigation notice for terms and liabilities.

- 2F PRICE: \$500.00 (Section I)
FINDINGS: Drywood termite damage was found at the sub floor in the apartment.
RECOMMENDATION: Remove and replace or reinforce damage wood members. Painting is included, color may not be an exact match.
- 2G PRICE: \$490.00 (Section I)
FINDINGS: Drywood termite damage was found at the attic rafters and ceiling joist.
RECOMMENDATION: Remove and replace or reinforce damage wood members. Painting is included, color may not be an exact match.

- 3A PRICE: \$590.00 (Section I)
FINDINGS: Fungus damage was noted at the fascia.
RECOMMENDATION: Remove and replace damaged wood members with new material. Painting is included, color match may not be exact.

- 3D PRICE: \$2,690.00 (Section I)
FINDINGS: Fungus damage was noted at the 2nd story fascia.
RECOMMENDATION: Remove and replace damaged wood members with new material. Painting is included, color match may not be exact.

- 3G PRICE: \$9,840.00 (Section I)
FINDINGS: Fungus damage was noted at the stairs and railing to the upstairs apartment.
RECOMMENDATION: Remove stairs, deck landing and railing. Install new material, painting is included.

- 3H PRICE: \$24,980.00 (Section I)
FINDINGS: The water proof deck coating is swollen and cracked, which has led to fungus damage in the plywood underneath.
RECOMMENDATION: Remove fungus damage wood members, deck coating and cut up stucco a foot around perimeter. Install new wood members, new flashing and re-seal the entire deck with a new water proof coating. Install new stucco around the perimeter, color may not be an exact match. The deck coating is a five step process and the deck may not be used for approximately 7-10 days. Install new deckboards on top and new railing.

- 3J PRICE: \$3,190.00 (Section I)
FINDINGS: Fungus damage was noted at the attic rafters and the roof sheathing.
RECOMMENDATION: Remove and replace damaged wood members with new material. Painting is included, color match may not be exact.
